NOVA Home Inspection LLC

Confidential - Property Inspection Report - Confidential

12345 Roland Drive, Vienna VA, 22180
Inspection prepared for: Sample Client
Inspection Date: 5/9/2009

Inspector: Sergio A. "Serge" DelHoyo
ASHI #248788 NRSB #9SS0016
www.novahomeinspection.com

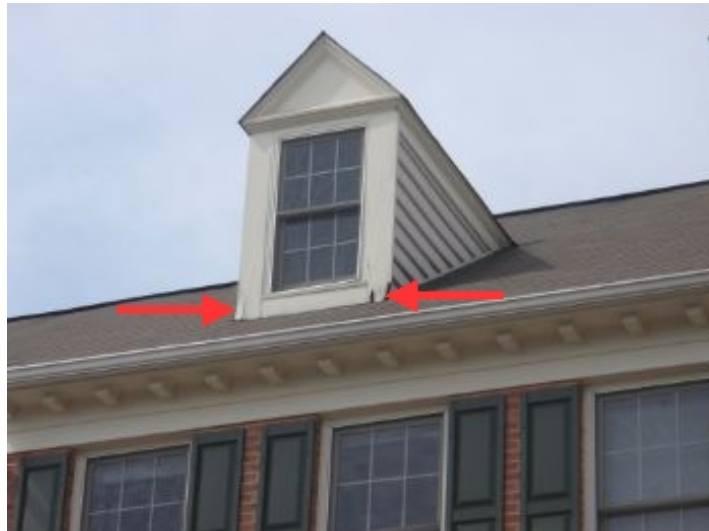
- All exterior painted wood trim surfaces should be annually examined and sealed, re-caulked and re-painted as needed.
- The exterior wood trim molding at roof dormers, in particular, the left one (as viewed from the front) is deteriorated and rotted. A qualified contractor should replace as needed.

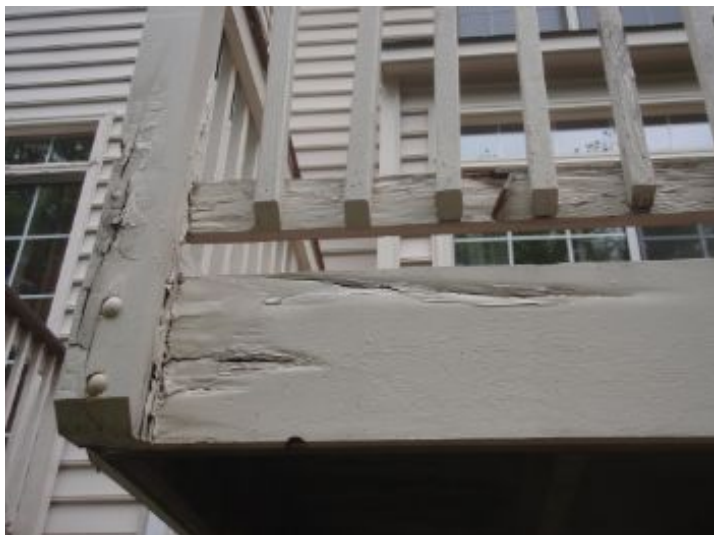
- Appears in satisfactory and functional condition with normal wear for its age. Except as noted.
- MAINTENANCE: Whether treated or not, it is important to keep a wood deck surface free of all forms of fungal growth and debris that retains moisture and will cause the deck to eventually rot. Recommend cleaning and resealing the deck annually. Cleaning can be accomplished by scrubbing the deck with a sodium-hypochlorite (bleach) and Tri-Sodium-Phosphate (TSP) deck wash and then rinsing with a pressure washer. Finally, a wood deck should be recoated with a good-quality deck sealant.
- The deck perimeter trim board -- non pressure treated wood -- is deteriorated and rotted. A qualified contractor should replace and repair as needed.

The deck perimeter trim board deteriorated and rotted

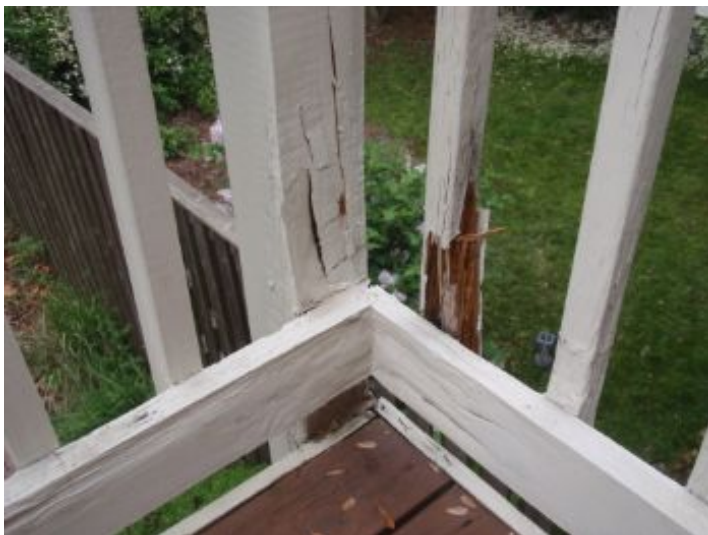
Several balusters are rotted and NOT SAFE

- SAFETY CONCERN: Portions of the deck balusters (vertical pickets) and the lower railing trim board are deteriorated and rotted. Qualified contractor should replace and repair as needed.

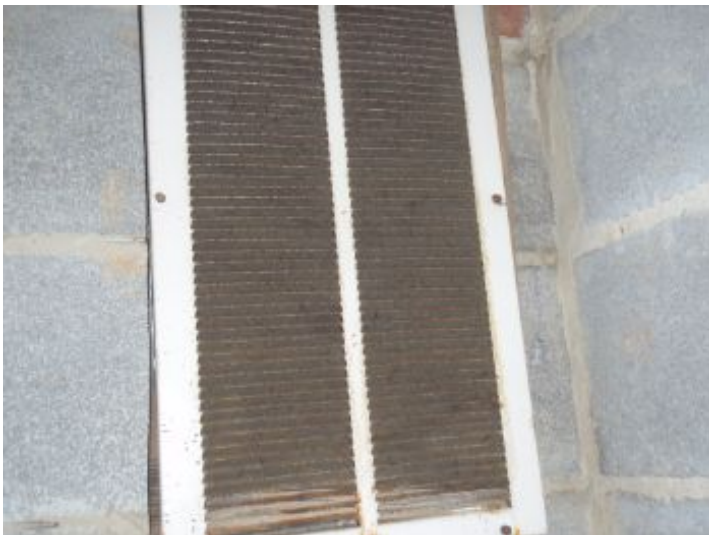
Vent opening under exterior entry stoop

- **SAFETY CONCERN:** The furnace/utility room combustion air vent opening, under the exterior entry stoop, is partially blocked with a dirty filter. Proper combustion air is not being provided for gas furnace and gas water heater. Recommend removal/replacing filter.

- **IMPROVE:** I recommend this existing grille be replaced with a 1/4" size square wire screen to keep out vermin from entering the structure. Also, removing the unnecessary filter. A qualified person should do the work.

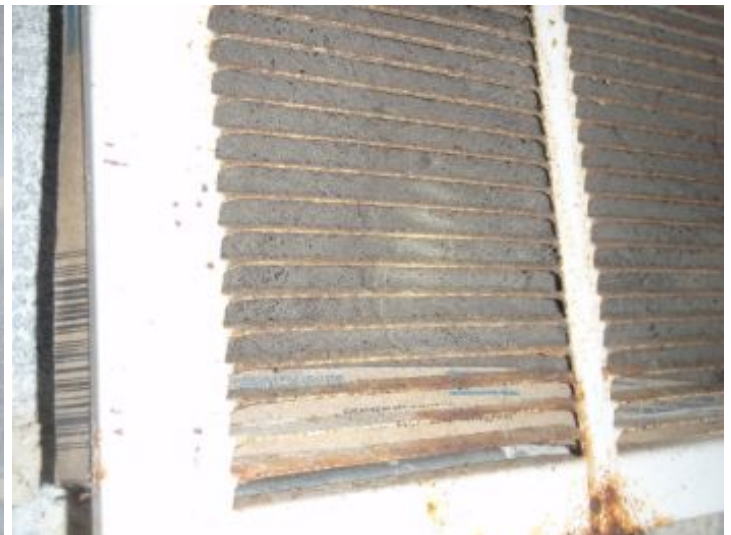
Clogged and blocked with dirty filter

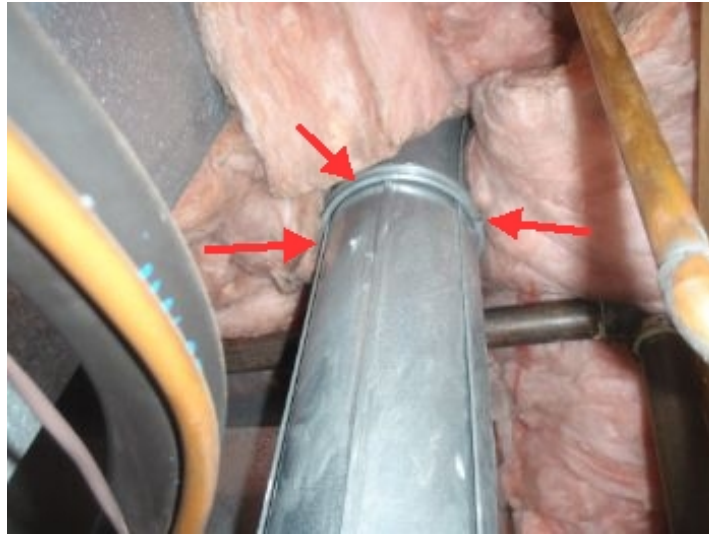
- Minimum furnace/water heater double wall vent pipe clearance from combustible material is 1".
- **SAFETY CONCERN:** Chimney flue/vent pipe has inadequate clearance to combustible materials. Repair as needed.

At least 1" clearance required from combustibles

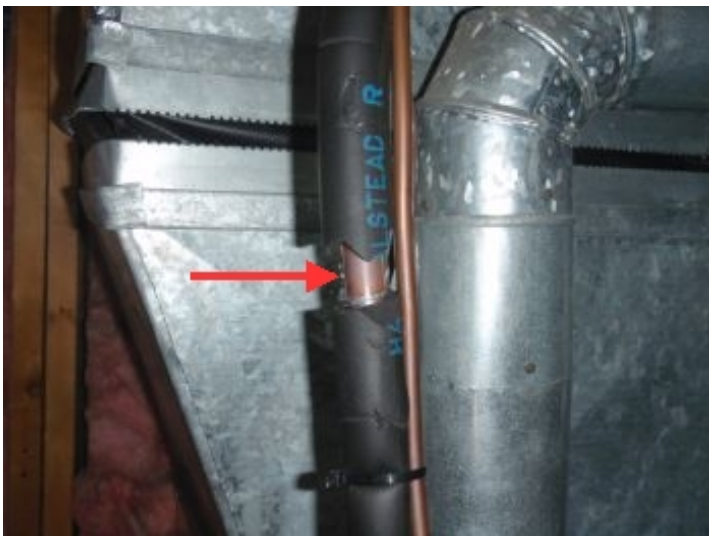
- Average life of an outside A/C compressor/condenser is approx. 12-15 years
- Annual/Seasonal professional HVAC inspection and cleaning service contract is recommended.
- DEFERRED COST: The outside A/C unit appears to be at the end of its life cycle.
- IMPROVE: Vegetation has grown too close to A/C Condenser unit. Recommend trim/prune as needed.
- The insulation is missing or damaged at interior refrigerant line. A qualified person should repair as needed.

Insulation missing at refrigerant line

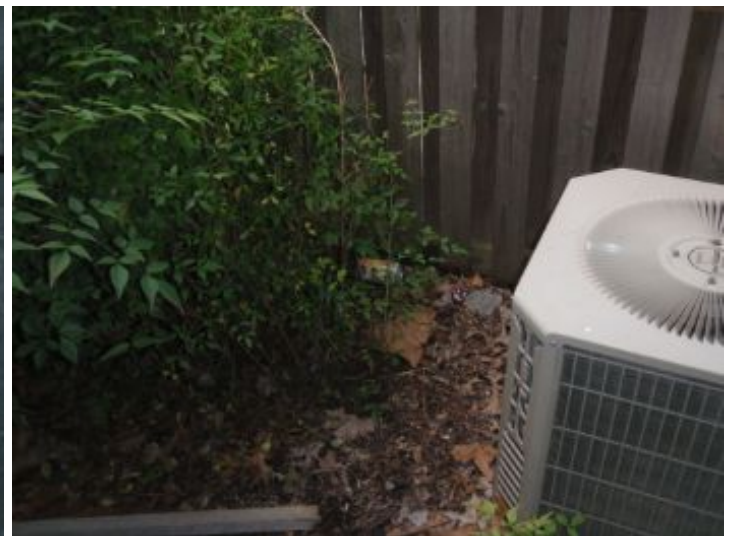
Vegetation needs pruning next to A/C Condenser

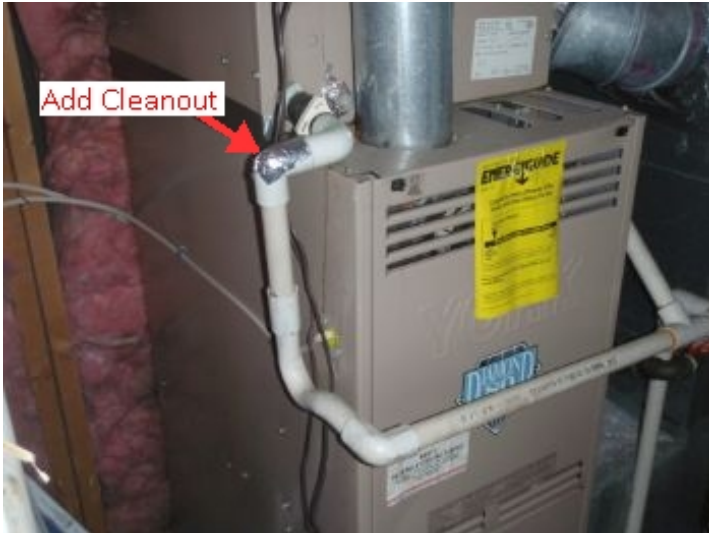
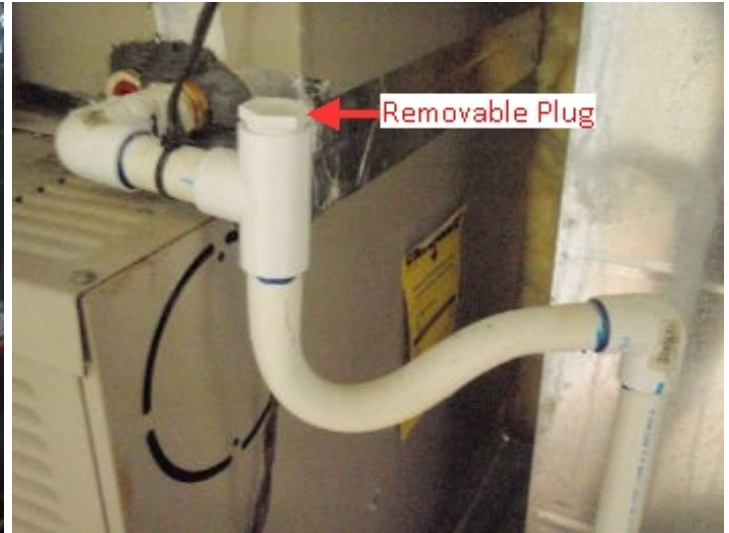
Example of a clean-out plug installed in condensate drain

- **IMPROVE:** Install a clean-out plug, with an easily removable cap, at each condensate trap. This allows access in order to maintain traps free of bacteria/mold growth and sludge buildup. This cleaning should be accomplished before the start of each cooling/Summer season. Recommend your HVAC contractor install these during the next service. See example photo.
- **MAINTENANCE:** Before the start, and during each cooling (Summer) season--it is important to monitor the condensate trap to insure it is clear of sludge/blockage for proper draining to occur. Recommend keeping a bottle brush handy for this purpose. Also, pouring a small amount of bleach in the trap, at the start of the season, will keep it clear of bacteria.

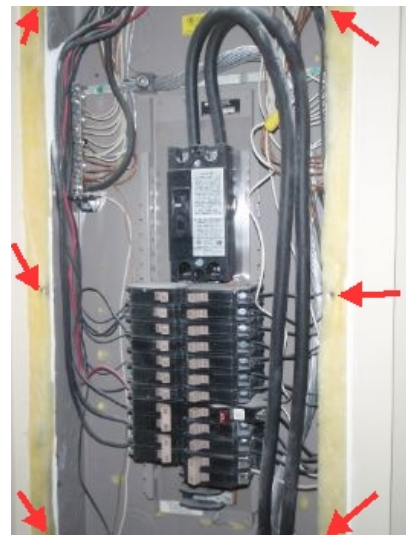
- The wiring within the panel appeared satisfactory - no deficiencies.
- **SAFETY CONCERN:** Pointed screws are in use attaching electrical panel cover. Blunt-end screws are required to prevent piercing electrical wiring resulting in arcing and electrical fire. A qualified person should replace as needed.

Blunt End Screws Required to Attach Panel Access

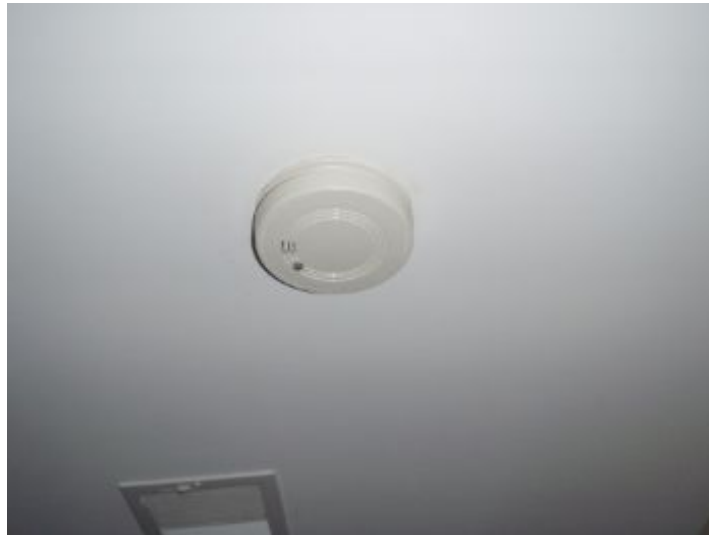
- Without a working smoke detector in your home you have no first alert to a possible fire.
- FYI: Smoke detectors last 6-10 years. Ten year old detectors are less than 50% effective. Recommend replacing.
- IMPROVE: Recommend installing one in each bedroom to bring up to modern safety standards. A qualified contractor should be used to install smoke detectors that are hard wired to the house electrical system.
- **SAFETY CONCERN:** The smoke alarm(s) did not operate when tested. You need to be alerted in case of a fire. Recommend repair or replacement of the smoke alarms.

Smoke detectors in the house Inoperative

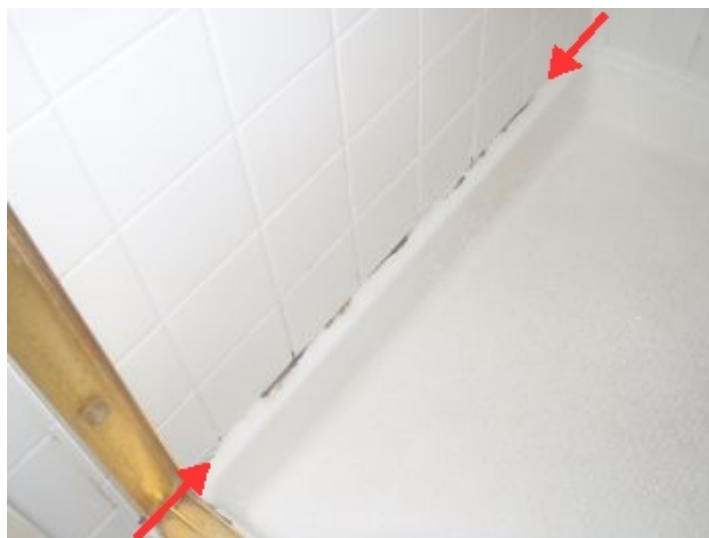
- Master shower: Recommend caulking as required. See Caulking comments below
- NOT INSPECTED: I did not inspect other showers - they contained personal items.

Caulking repair needed at master shower stall

- FYI: One of the best is : POLYSEAMSEAL Tub and Tile Ultra Sealant caulk.
FMI: Refer to the following site: <http://polyseamseal.com/ttultra.shtml>
- I highly recommend that any caulking issues/deficiencies listed in this inspection report, be addressed and corrected by the client (buyer) and not the seller. The reason is: Old caulk must be removed--the surface meticulously cleaned--THEN new the caulk applied. A seller may not always have the best interest in mind for a thorough job--that will may have to be re accomplished.

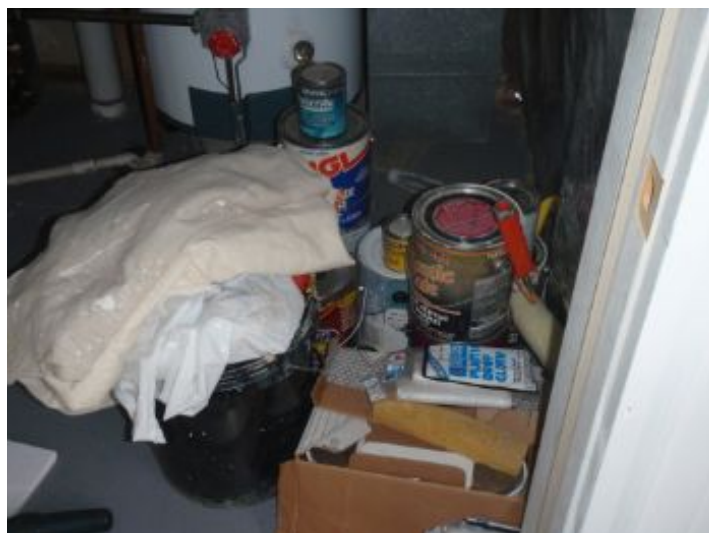
- Appeared satisfactory, at time of inspection.
- SAFETY CONCERN: Flammable materials should not be stored near gas burning appliances and within closed garage areas.

Combustible materials stored in furnace room.
