Property Inspection Report

1234 Sample Report Rd, Virginia Beach, VA 23456
Inspection prepared for: Mr. and Mrs. Sample
Real Estate Agent: Top Agent - Virginia Beach Realty

Date of Inspection: 11/25/2014

Inspector: Troy Pappas

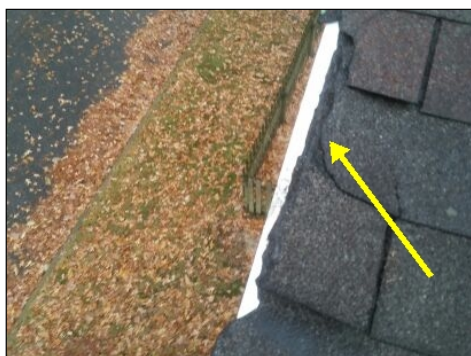
2.4. There were damaged shingles at the roof. Damage to shingles reduces the overall lifespan of the roof covering system. You should have all damaged shingles replaced. LOCATION: front upper left side

Shingle damage

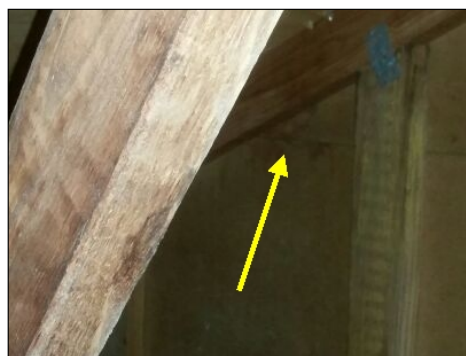
Moisture intrusion under damaged shingle

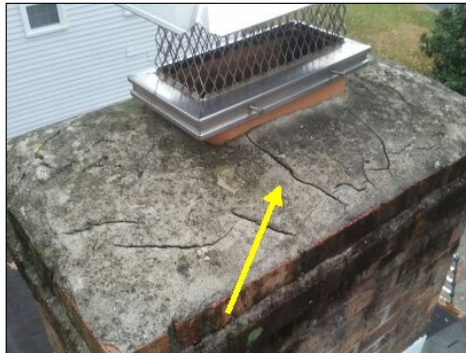
5.1. There was damage or wear at the chimney crown. You should have the mortar crown repaired. You should have a qualified chimney contractor make all necessary repairs or replacement.

Chimney crown needs repair

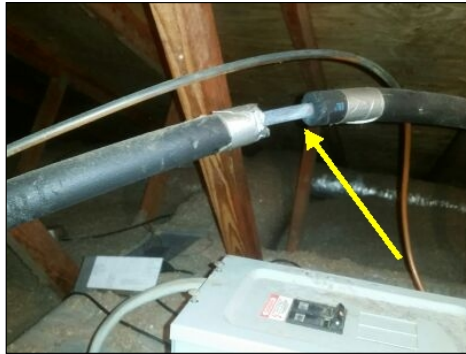
8.1. There was insulation missing or damaged in the attic at the suction line between the indoor coil to the outside condenser. This can cause moisture issues and attract vermin due to condensation on the line. You should have all damaged or missing suction line insulation repaired or replaced.

Repair or replace insulation

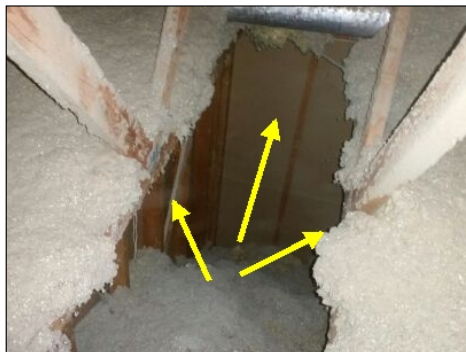
9.2. The attic was missing areas of insulation. The inspector recommends having the insulation levels installed to current standards. LOCATION: walls of attic stairwell

Areas missing insulation

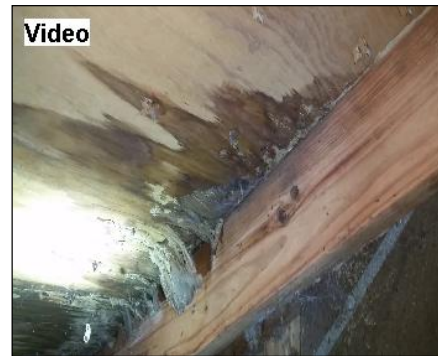
11.1. There was moisture damage and WDO damage to the underside of roof sheathing visible in the attic. The inspector recommends inspection by a qualified pest control contractor and have repaired as needed. LOCATION: left front corner of garage attic

CLICK to VIEW video of garage attic damage

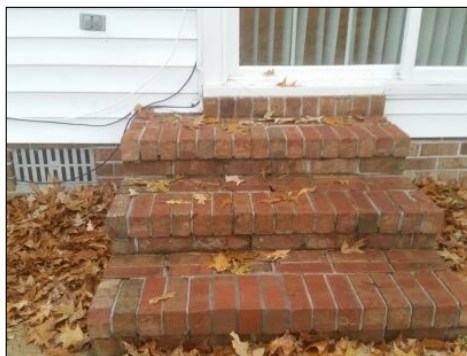
4.2. SAFETY CONCERN: The exterior staircase had no handrail. Safe building practices dictate that stairs with 4 or more risers should have a handrail. LOCATION: rear

Uneven risers and no handrail

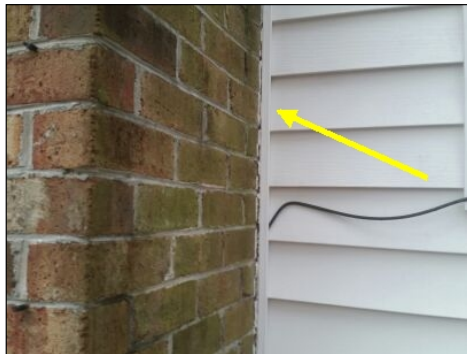
9.1. MAINTENANCE: The exterior sealant was in generally good condition. There were some areas that needed maintenance.

Sealant maintenance needed

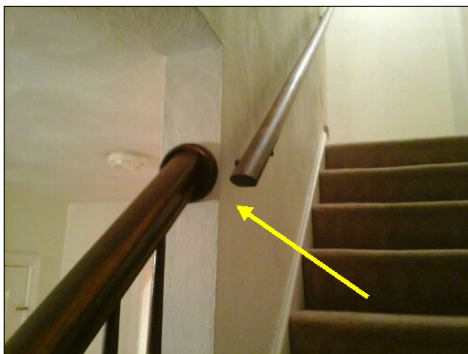
6.1. FYI: The handrail was not continuous over the full length of the flight of stairs from top riser to bottom riser. For safety reasons, you should consider that the handrail be altered or replaced with one of the proper configuration.

Non continuous handrail

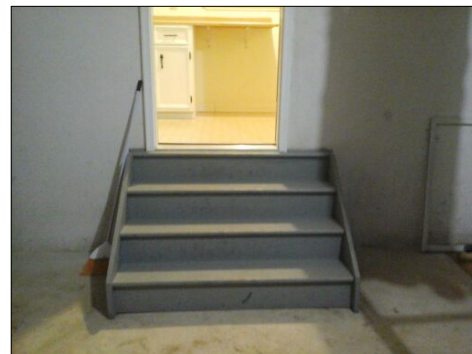
6.2. SAFETY CONCERN: The interior staircase (SEE PICTURE) had no handrails. Safe building practices dictate that stairs with 4 or more risers should have a handrail.

No handrail

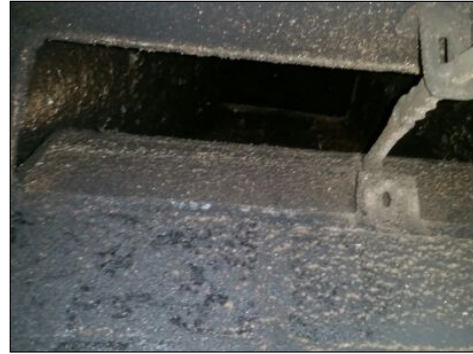
7.1. The interior of the firebox and flue were dirty. You should have a qualified chimney sweep evaluate and provide estimates for all necessary service.

Dirty flue

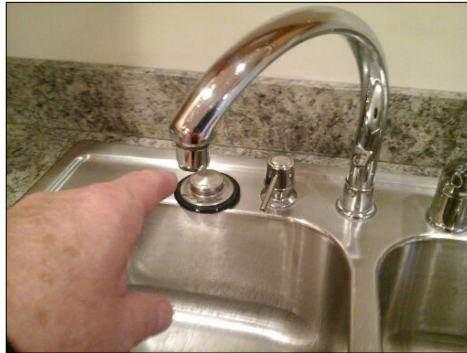
1.1. The kitchen sink faucet was leaking. You should have repaired as needed.

Leaking

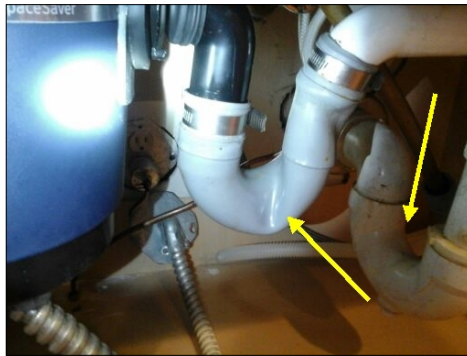
2.1. There was a double trap under the kitchen sink which in an unapproved arrangement and can lead to clogging of the pipes. You should have corrected.

Double trap at kitchen sink

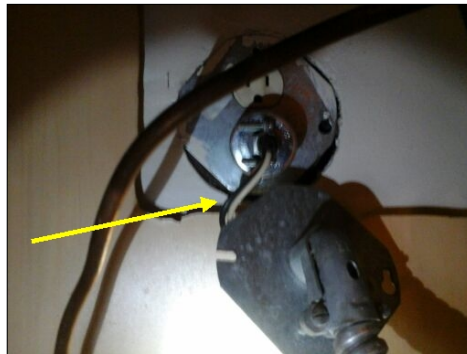
- 5.1. The garbage disposal was functional at the time of inspection.
- 5.2. The electrical connection to the garbage disposal was exposed to damage. You should have this repaired.

Exposed wiring

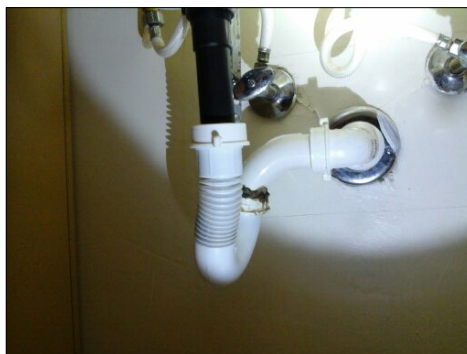
3.2. There was an unapproved, flexible, corrugated drainpipe that will contribute to blockages at a bathroom sink(s). Although they were functioning, it is recommended that this be replaced with the proper drain material. LOCATION: Upstairs hall bathroom

Improper corrugated drain line

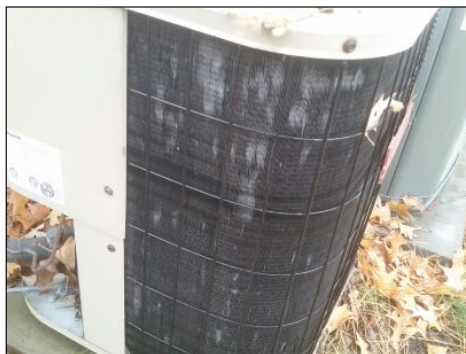
Fin damage

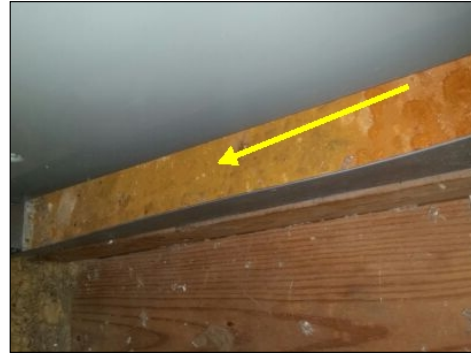
8.2. **FYI:** There was rust observed in the condensate drain pan indicating that there was a failure in the primary condensate drainage system. This may or may not have been corrected. You should consult with seller regarding the condition to determine if this issue has been serviced.

Rust in condensate pan

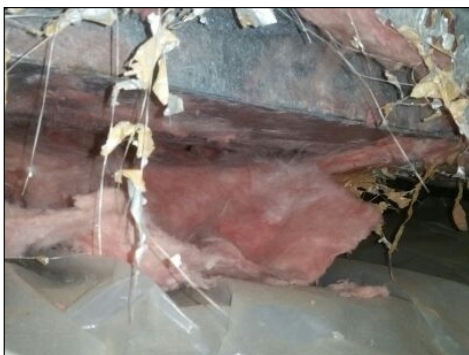
9.3. There were air supply ducts routed through unheated spaces that had damaged or missing insulation. The inspector recommends having all uninsulated duct work in unheated spaces properly insulated. LOCATION: crawlspace

Insulation damaged at ductwork

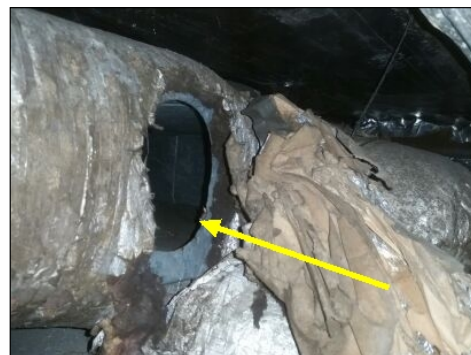
Disconnected ductwork

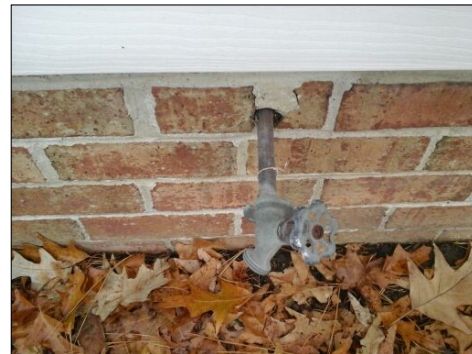
Loose hose bib

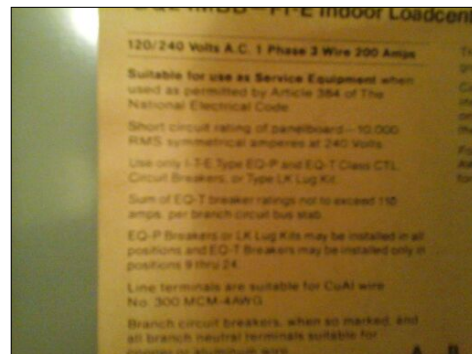
2.2. There were circuit breakers in the main electrical service panel that were not listed by the **panel manufacturer**. You should contact a qualified electrical contractor should be ensure the breakers are classified for this panel.

Manufacturer states use only their breakers

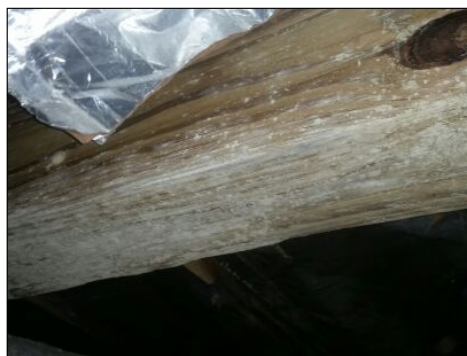
2.4. There was evidence of bio growth and WDO presence in multiple areas of the crawlspace. The majority of the crawlspace framing was not visible due to the installation of a radiant barrier. The radiant barrier was rendered ineffective by damage in multiple areas. It is recommended that the barrier be removed to allow for a full inspection for possible moisture damage and WDO damage.

Biogrowth observed

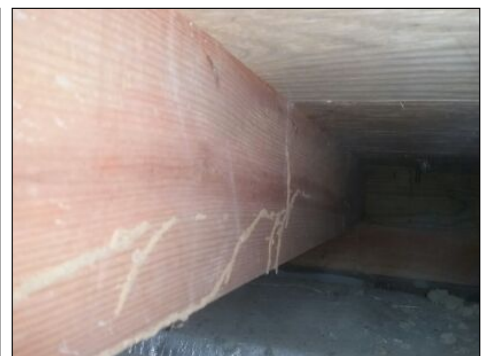
Termite tubes observed
