Freedom Express Home Inspections

Property Inspection Report

, Ponca City OK, 74601
Inspection prepared for:
Inspection Date: 1/4/2008 Time: 10:30 AM
Weather: Clear 45 degrees

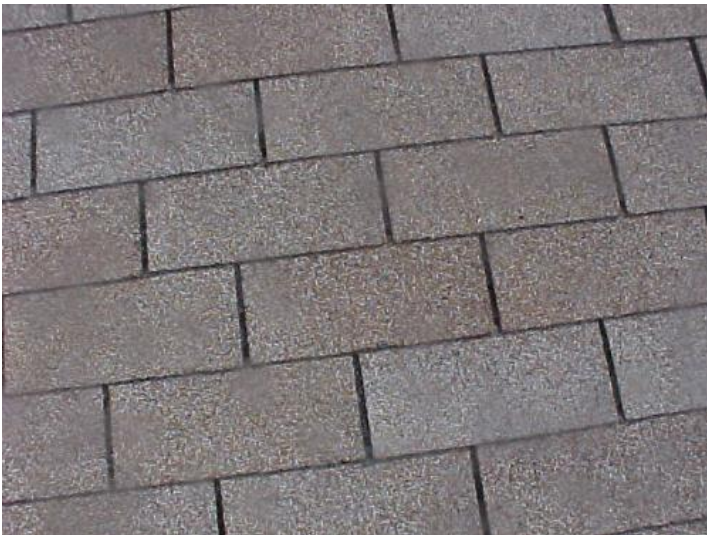
Shingles No hail

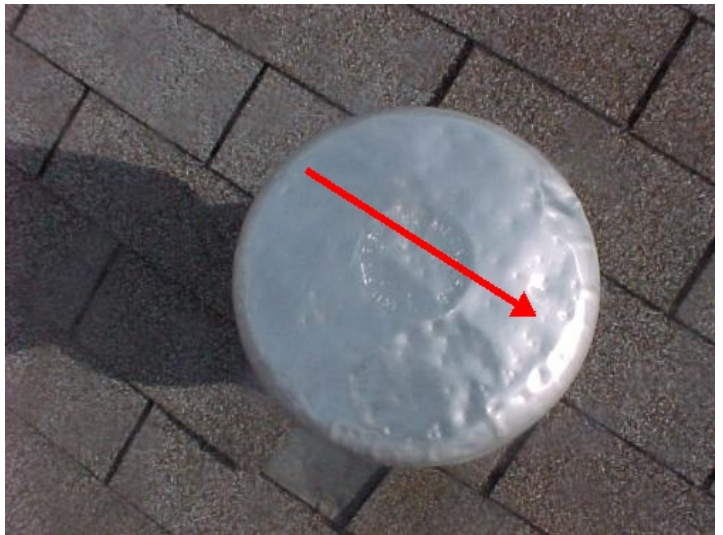
Past hail dings to vent cover

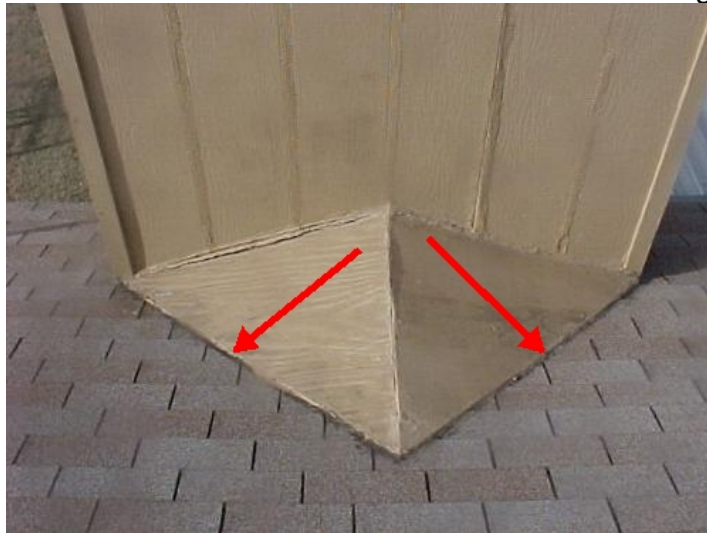
3. The wood type cricket installed on the surface of the shingles to deter water away from the chimney is improperly installed and constructed of the improper type of material. Crickets are normally constructed of metal and are installed under the shingles not on the surface. When wood crickets are used they normally are covered with shingles the same as the roof covering. Recommend a roofing contractor be consulted for a price estimate of repairs.

The wood type cricket installed on the roof surface to deflect water away from the chimney was improperly installed with wood and should be constructed of metal and be installed under the shingles instead of on the top of the shingles as indicated in the pictures. When wood crickets are installed they are required to be surfaced with shingles the same as the roof covering. The dry wall ceiling to the north of the fireplace in the living room is indicating a past leak. This dry wall ceiling was check with a moisture meter and an infrared camera that detects moisture. Both moisture detecting devices indicated no moisture present at the time of inspection.

Improper roof cricket

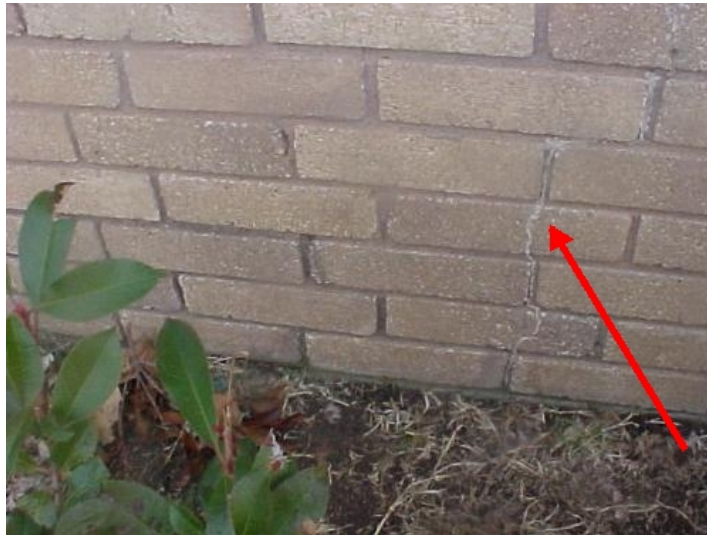
Wall Materials: Exterior siding brick veneer. Interior walls are covered with Drywall. Hairline mortar joint cracks visible in the brick veneer siding should be considered as normal settling

Hair line mortar joint crack below window west side S.W. corner

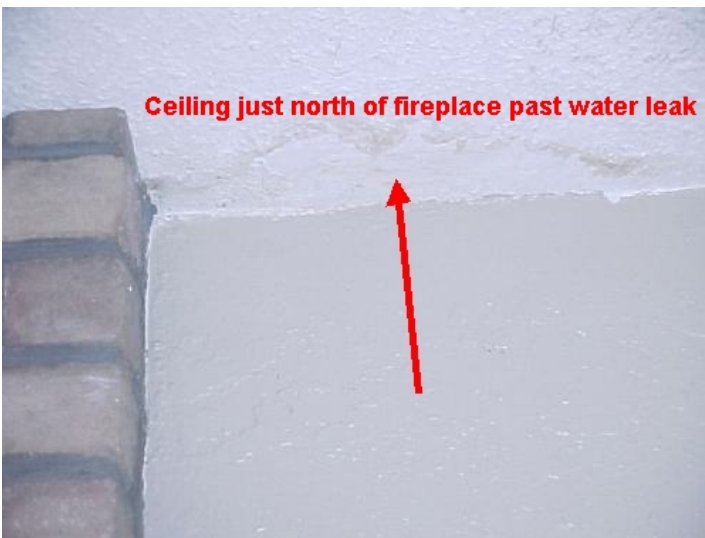
Comments: Small stains visible

Ceiling just north of fireplace

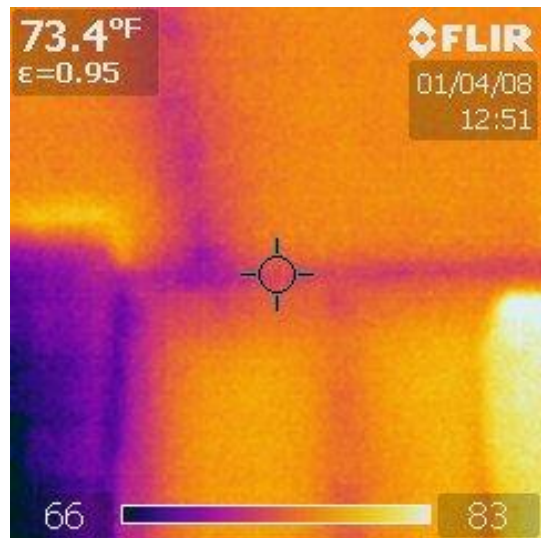
Infrared image of ceiling north of fireplace indicating no moisture

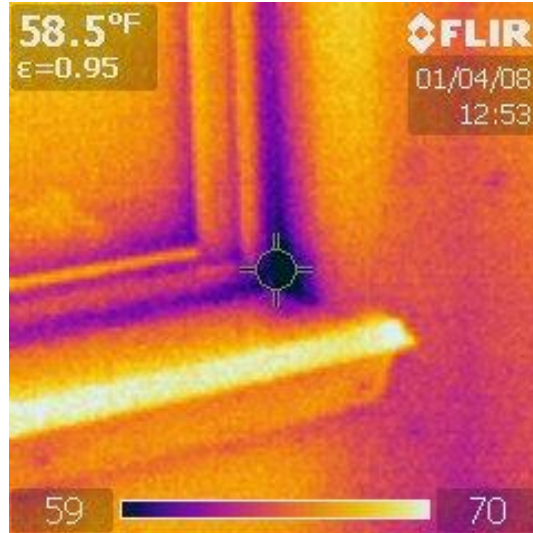
Infrared image indicating air intrusion at the corner of the windows dining room

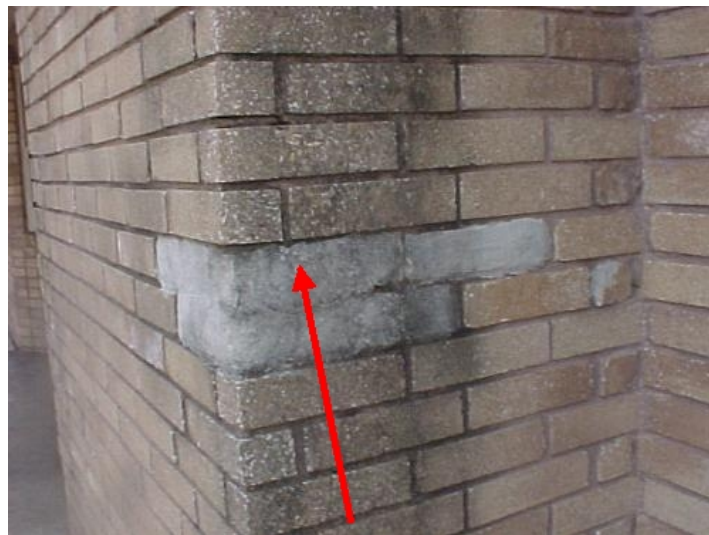
Cosmetic brick spalling exterior chimney as the result of no guttering

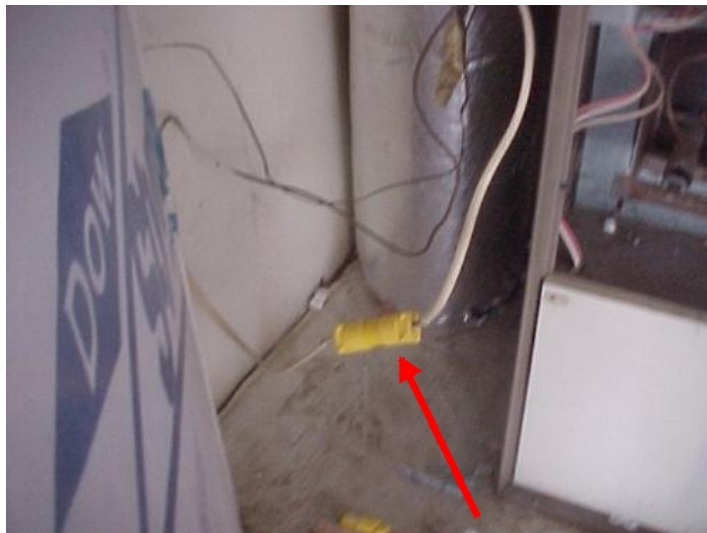
2. A. The electrical outlet in the cabinet for the microwave has reverse polarity. B. The front entry exterior light and the exterior light from the walk through door of the garage does not operate recommend it be determined bulb or fixture. C. The electrical supply wiring from the wall to the gas fired furnace does not meet requirements. Estimated cost of labor and material \$200.00

Improper electrical supply to furnace

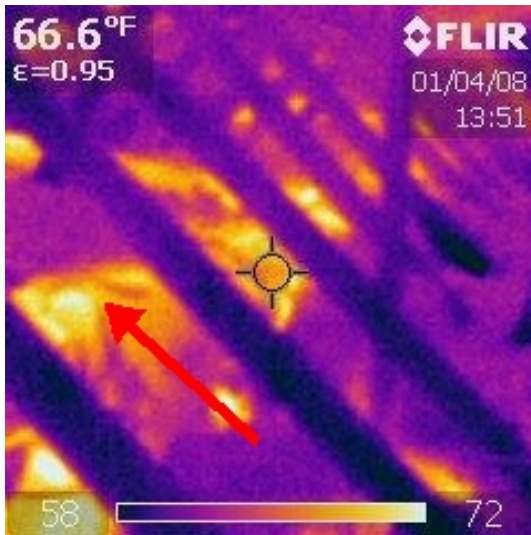
Air distribution ducts in the attic with the furnace operating Infrared Picture

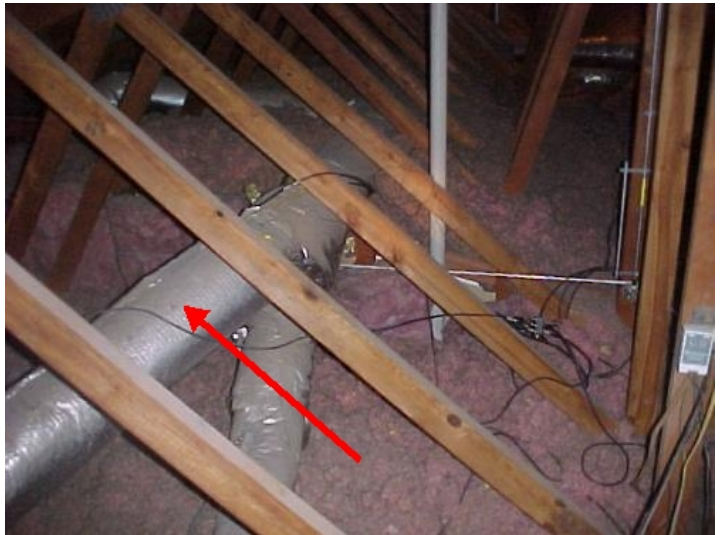
A/C ducts in the attic same as Infrared Picture

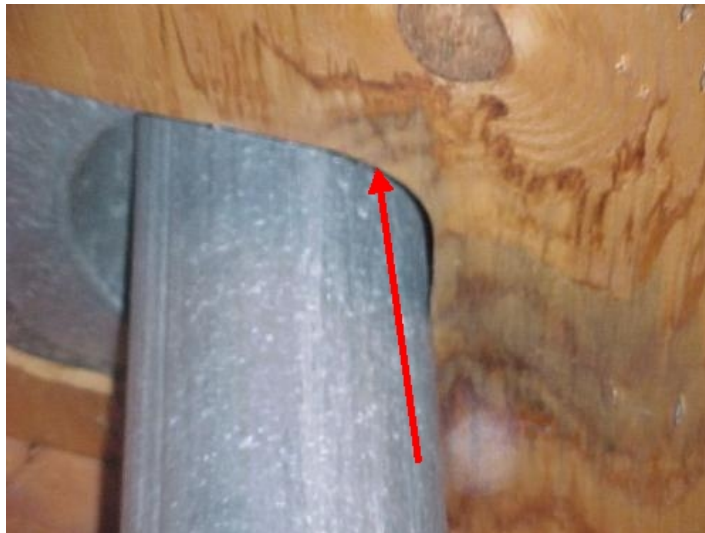
1. A. The dryer vent within the attic appears to be stopped up with lint, does not properly extend beyond the roof decking and has improper flex corrugated duct installed. Flex duct cannot extend beyond the dryer connection at the wall. B. The main bathroom just off of the hall tub faucet is leaking at the stem. C. The drain valve for the hot water heater is dripping water. D. The hotwater heater relief valve downspout has a rubber hose traveling to a PVC plastic drain that is not rated for hot water. Recommend a metal downspout be installed within 6 inches of the floor for safety. E. The dishwasher drain hose does not have a high loop to prevent waste from backing into the dishwasher in the event of sewer line blockage. F. The furnace flue vent does not have the required 1 inch clearance to combustibles at the roof penetration. Estimated cost of labor and material \$400.00

Furnace flue vent improper clearance at the roof

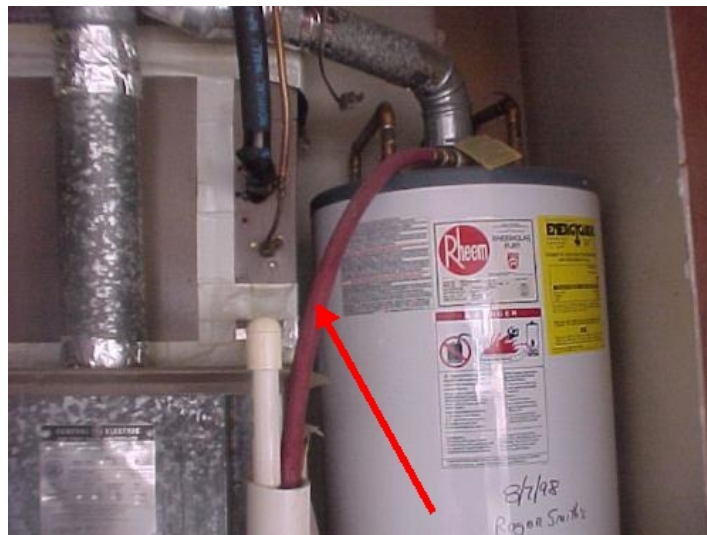
Comments: The gas fired water heater installed within the garage closet is raised in height to meet requirements. The gas fired water heater installed within the garage closet has combustion air for its burner provided from the attic. **Leaking from the drain. The hot water heater relief valve does not have a downspout to within 6 inches of the floor for safety**

Improper Relief valve downspout hot water heater

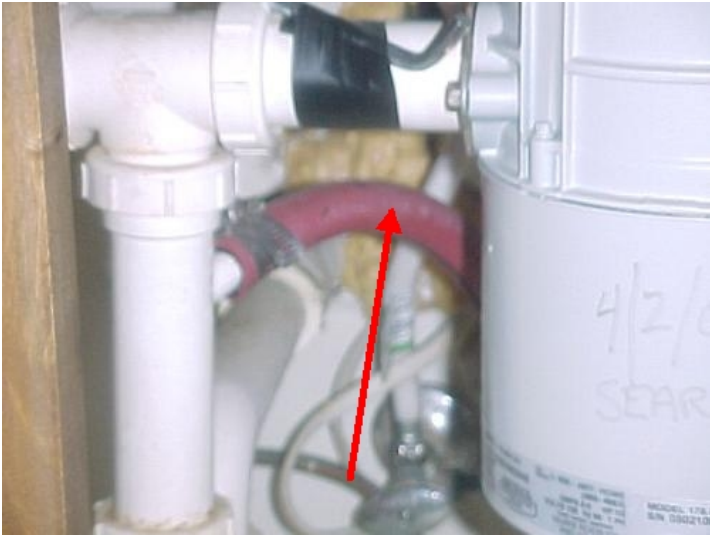
No High loop on dishwasher drain line

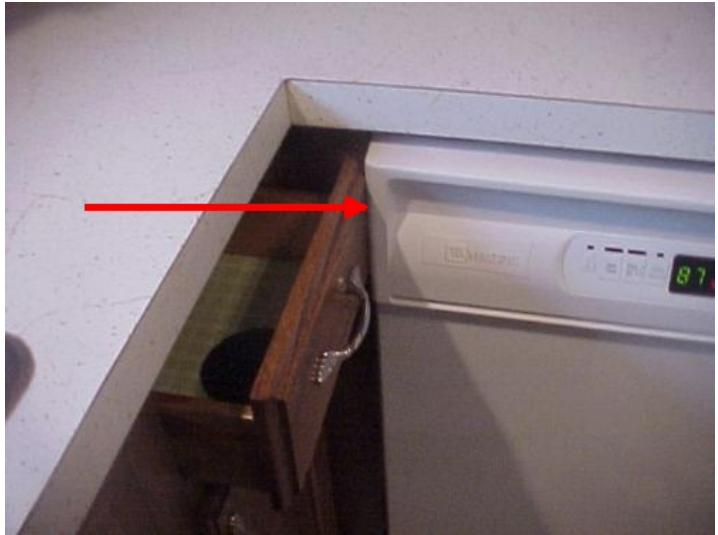
Dishwasher door prevents drawer from opening

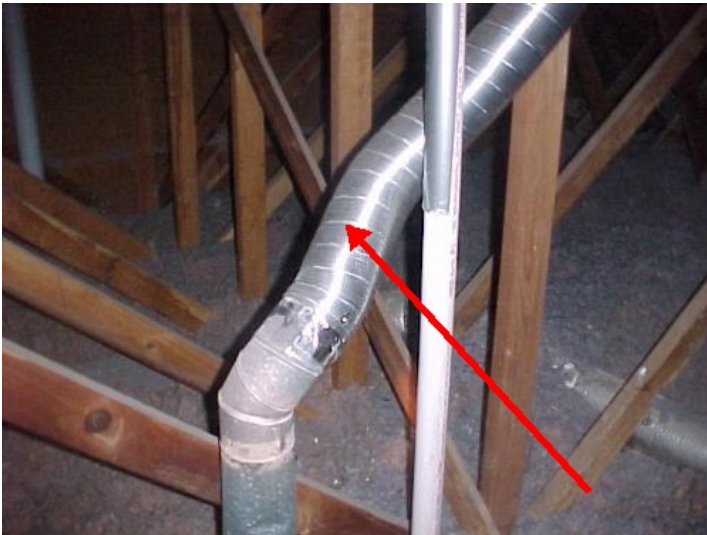
Comments: 220-volt electrical outlet and gas service available for the dryer, **Vent terminates into attic, Vent does not extend to the exterior of the structure as required, Flex duct not allowed beyond 5 feet of the dryer, Vent is clogged with lint**

Improper dryer vent not exiting the interior of attic

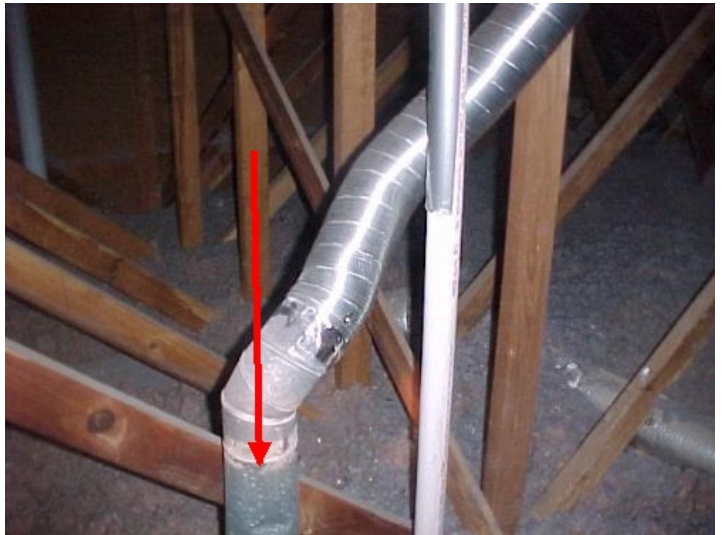
Dryer vent appears to be stopped up from arrow downward
