Accurate Inspections Inc. Property Inspection Report

1221 N. Harvest Walk Dr, La Puente CA, 91555 Inspection prepared for: John Felix & Jan Felix Agent: Jane Smith - Smith Realty

Inspection Date: 8/1/2007 Time: 3:30 to 5:45 Weather: Sunny

Inspector: Mike Verlingo

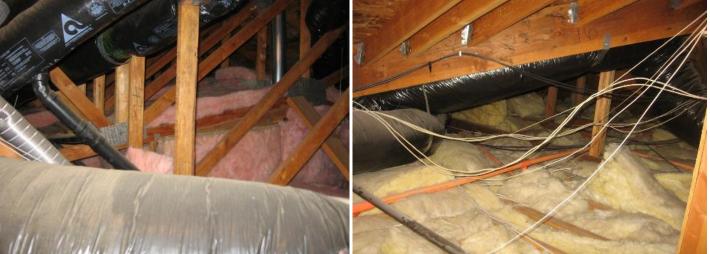
Attic Access

Attic
1. A	cces	S			
Good	Fair	Poor	N/A	None	Observations: The attic was accesible through the master bedroom closet.
Х					
15			-

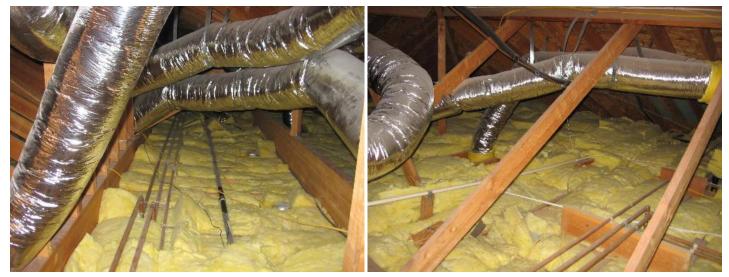
Attic Duct Work

Observations: The duct work appeared functional. For a thorough inspection I recommend an evaluation by a Heating & A/C contractor.

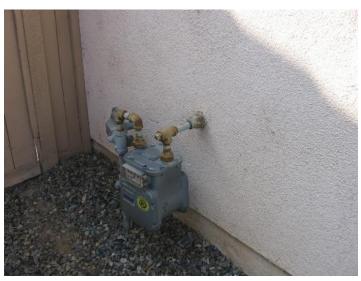
Main Gas Valve

Good	Fair	Poor	N/A	Materials: east side
X				Observations: Main gas into the house is natural gas., No seismic shut off
				present., I recommend having the Gas Company evaluate the valve.
				present., rrecommend naving the Cas company evaluate the valve.

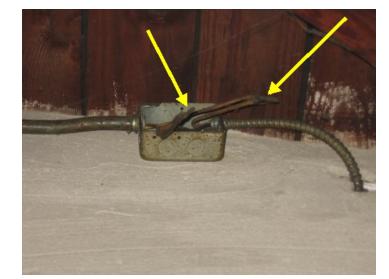
Missing wire nuts

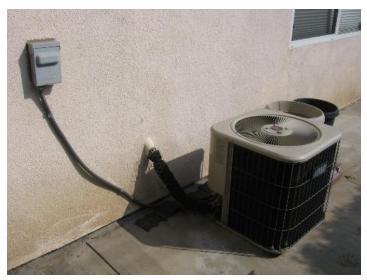
Heating AC Compress Condition

5. Thermostats Good Fair Poor N/A None X Image: Source of the second sec
6. Venting
Good Fair Poor N/A None X
7. Filters
Good Fair Poor N/A None Observations: Filters were dirty. I recommend replacing the filters to ensure proper function of the heating system
9 Air Supply
8. Air Supply Good Fair Poor N/A None Observations: The air supply was functional X Image: N/A None
0. Degistere
9. Registers Good Fair Poor N/A None X Image: Source of the second secon
10. Refrigerant Lines
Good Fair Poor N/A None Observations: Refrigerant lines could not be fully inspected due to inaccesability. The lines were functional
11. AC Compress Condition
Good Fair Poor N/A None X A Materials: electric Materials: patio area Observations: A/C Compressor operated at 49 degrees

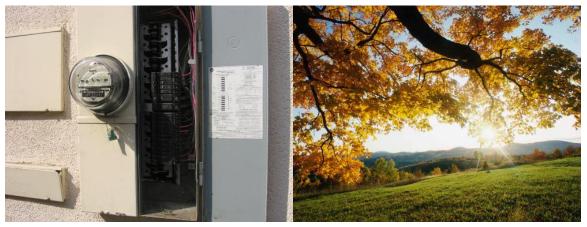
Attic	-	
Page 3 Item: 7	Attic Plumbing	Several of the vent pipes terminate in the attic. This can cause a buildup of moisture and eventually mold in the attic.
Electrical		
Page 9 Item: 1	Electrical Panel	There was evidence of water within the panel., I reccommend having a licensed electrician evaluate., 14 gauge wire runs to a 30 amp breaker, improper electrical installation, Undersized wires to a breaker.
Page 10 Item: 7	Main Gas Valve Condition	No seismic shut off present., I recommend having the Gas Company evaluate the valve.
Garage		
Page 16 Item: 13	Fire Door	The fire door from the garage to the kitchen did not self close and latch
Grounds		
Page 20 Item: 13	Sprinklers	Visible leaking of sprinker valves.
Heating		
Page 21 Item: 1	Heater Condition	Cable wire for television runs over the heater
Page 22 Item: 7	Filters	Filters were dirty. I recommend replacing the filters to ensure proper function of the heating system
