## Accurate Home Inspections Property Inspection Report

1221 N. Harvest Walk Dr, La Puente CA, 91555 Inspection prepared for: John Felix & Jan Felix Agent: Jane Smith - Smith Realty

Inspection Date: 8/1/2007 Time: 3:30 to 5:45 Age: 1980 Size: 1500 square feet Weather: Sunny

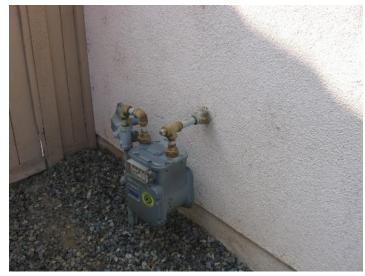
Electri	cal
1. Electrical Panel	
within the panel., I reccomme	es to a breaker., There was evidence of water nd having a licensed electrician evaluate., 14 breaker, improper electrical installation,
Electrical Panel	Electrical Sub Panel
2. Main Amp Breaker	
Good     Fair     Poor     N/A     None       X     Image: Source of the second	
3. Breakers in off position	
Good     Fair     Poor     N/A     None       X         Observations: 0	
4. Breakers	
Good         Fair         Poor         N/A         None           X         A         A         Observations: All breakers we	ere functional.
5. Fuses Good Fair Poor N/A None X	
6. Cable Feeds	
Good Fair Poor N/A None Observations: Electrical cable	e feeds were located underground.
7. Main Gas Valve Condition	
	he house is natural gas., No seismic shut off the Gas Company evaluate the valve.

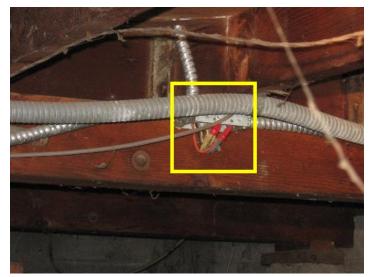
### 12. Foundation Electrical

Exposed electrical connections. Missing junction box cover.

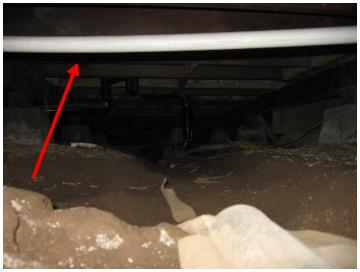
Foundation Plumbing

Good	Fair	Poor	N/A	None	Observations: The foundation plumbing could not be accessed.
			Х		
			<i>/</i> \
