NOVA Home Inspection LLC

Confidential - Property Inspection Report - Confidential

12345 Roland Drive, Vienna VA, 22180
Inspection prepared for: Sample Client
Inspection Date: 5/9/2009

Inspector: Sergio A. "Serge" DelHoyo
ASHI #248788 NRSB #9SS0016
www.novahomeinspection.com

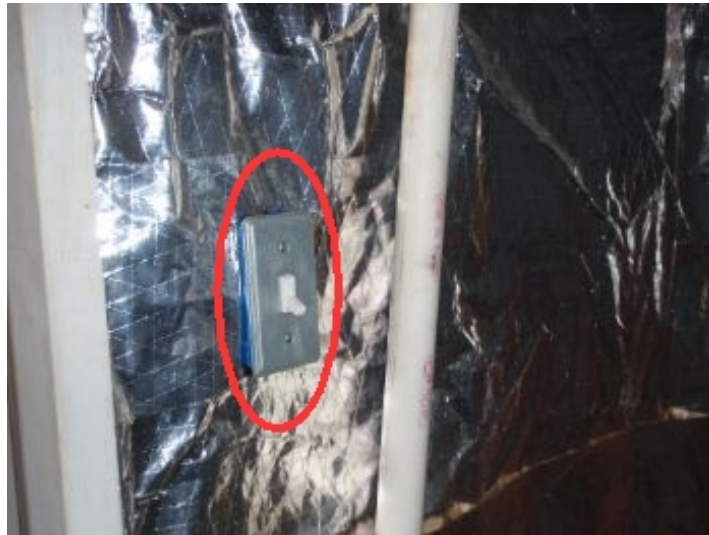
Furnace Electrical Safety Switch on Wall next to Furnace

- No deficiencies noted.

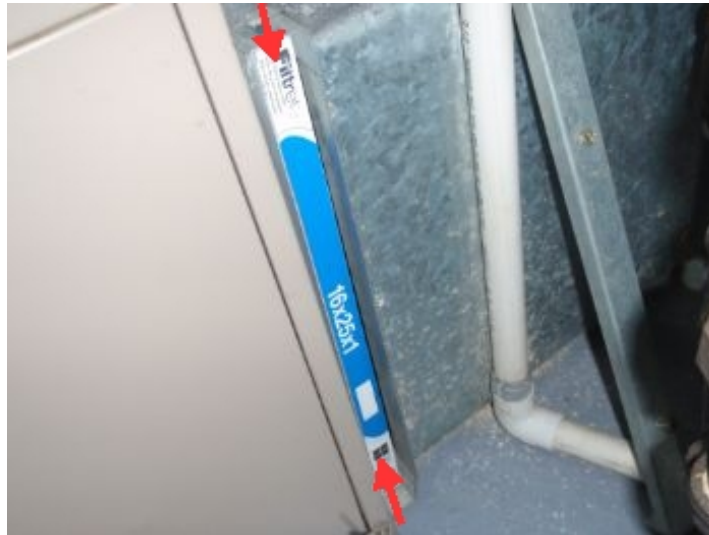
16 X 25 X 1 Size

- **MAINTENANCE:** The air filter(s) should be inspected at least monthly and cleaned or replaced as required. There are two types of filters commonly used: (1) Washable filters, (constructed of aluminum mesh, foam, or reinforced fibers) these may be cleaned by soaking in mild detergent and rinsing with water. Or (2) Fiberglass disposable filters that must be REPLACED before they become clogged. Remember that dirty filters are the most common cause of inadequate heating or cooling performance.
- The return air vents in the ground level, main floor, and upper level hall ceiling, all have dirty filters installed. This results in less efficiency in both heating and cooling. These return air grilles are not designed for filters. Recommend removal of filters.

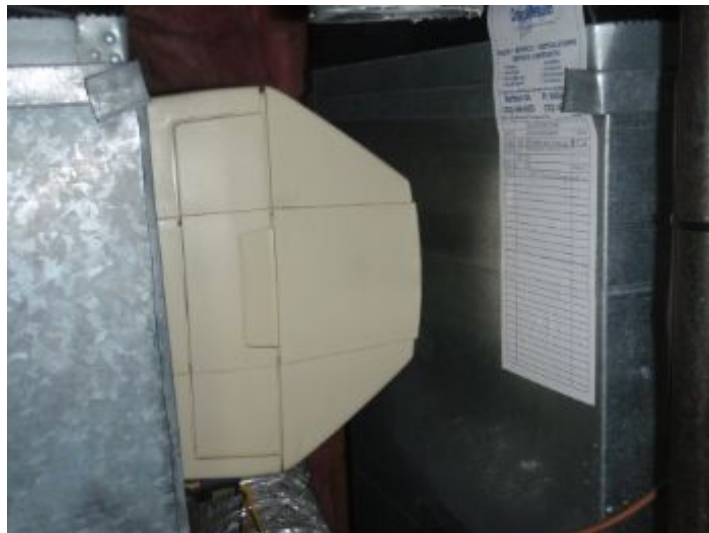
Aprilaire Humidifier

- Humidifiers require routine annual service prior to each heating season. They easily become covered by lime deposits which cause them to become inoperative within short periods of time. This should be part of annual/seasonal HVAC service contract.

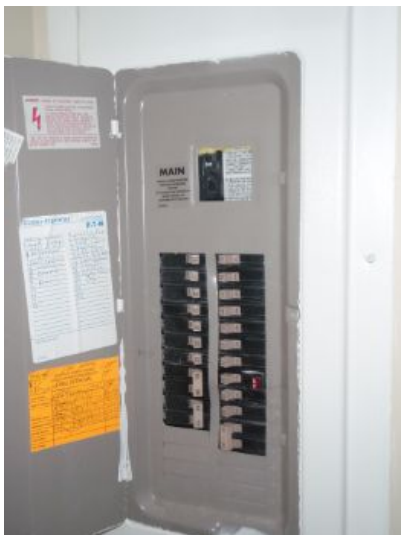
Cutler-Hammer brand electrical panel

- The wiring within the panel appeared satisfactory - no deficiencies.
- **SAFETY CONCERN:** Pointed screws are in use attaching electrical panel cover. Blunt-end screws are required to prevent piercing electrical wiring resulting in arcing and electrical fire. A qualified person should replace as needed.

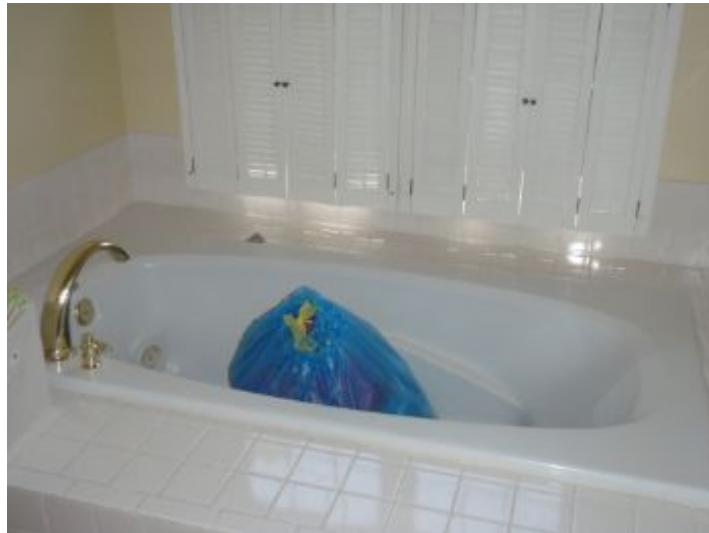
Master bathroom Jacuzzi brand tub

- NOT INSPECTED - Tubs contained personal items.
