Property Inspection Report

1234 Sample Report Rd, Virginia Beach, VA 23456
Inspection prepared for: Mr. and Mrs. Sample
Real Estate Agent: Top Agent - Virginia Beach Realty

Date of Inspection: 11/25/2014

Inspector: Troy Pappas

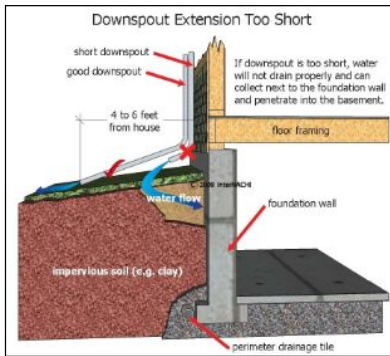
Downspout extension example

3.1. The downspouts should discharge water away from the house at least 4ft. There is potential for damage to the foundation and water intrusion into the crawlspace if correction is not pursued. You should have extensions installed or pursue other methods of drainage.

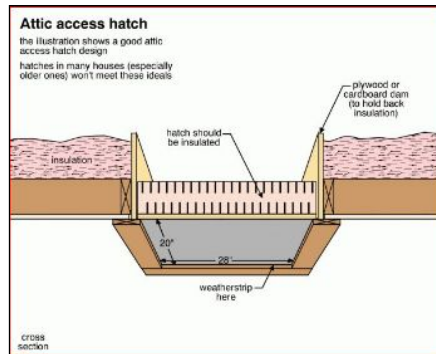
7.1. **IMPROVE:** The attic access was not insulated. Therefore you should expect some energy loss through convection. The inspector recommends insulating attic accesses with proper level of insulation to reduce energy expenses.

Attic access insulation example

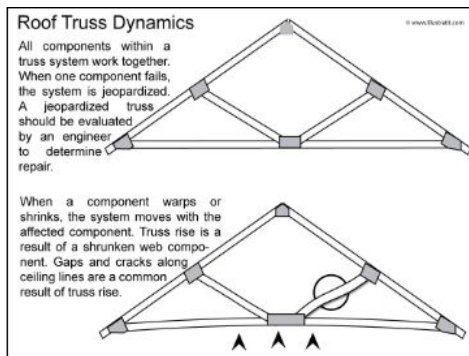
11.1. There was moisture damage and WDO damage to the underside of roof sheathing visible in the attic. The inspector recommends inspection by a qualified pest control contractor and have repaired as needed. LOCATION: left front corner of garage attic

Roof truss information

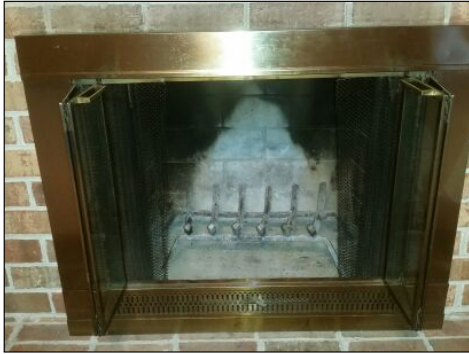
7.1. The interior of the firebox and flue were dirty. You should have a qualified chimney sweep evaluate and provide estimates for all necessary service.

Masonry wood burning fireplace

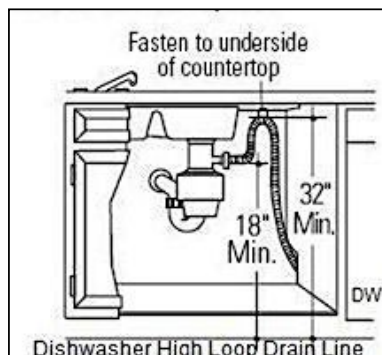
4.2. There was no high loop installed to prevent water from the sink drain or disposal from entering the dishwasher. You should have a proper high loop installed.

Dishwasher high loop example

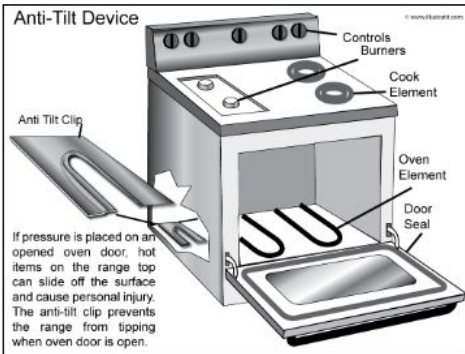
- 6.1. The heating elements/burners and oven operated when tested. This does not confirm the efficiency of the system.
- 6.2. There was no anti-tip device observed at the range. This is a safety device that should be installed.

Anti-tip device information

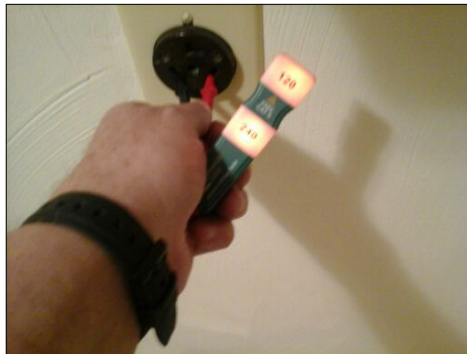
11.2. FYI: A three prong 240 Volt electrical outlet has been installed, which was standard at the time of construction. Therefore, it will be necessary to have to convert a newer dryer's four prong cord to fit this three prong outlet.

3 Prong outlet - Functional

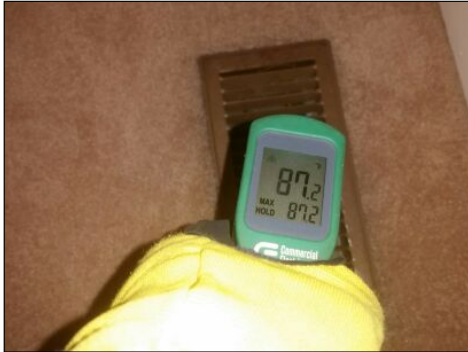
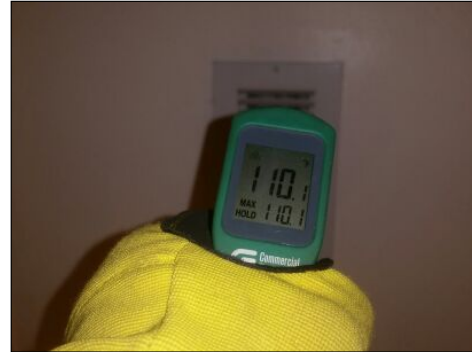
2.2. FYI: The emergency heat setting was turned on at the thermostat and heat was being delivered during the inspection.

Auxiliary heat functional

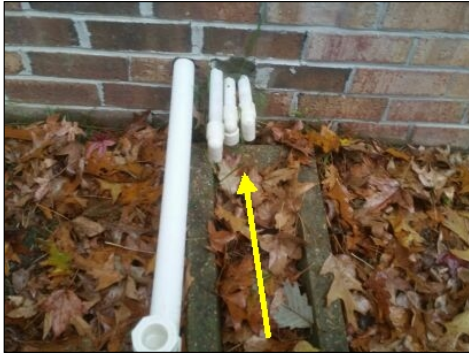
8.1. **IMPROVE:** The auxiliary condensate drain is next to the primary drain. It should discharge to a conspicuous location, such as above a window, door, patio, or deck, where any discharge would be readily noticed. If it is not relocated, you should have the auxiliary condensate drain identified and marked in a way that it is distinguishable from the primary drain line so that you are aware when it is draining. When the auxiliary line is draining call a HVAC technician for service.

Recommend identifying the auxiliary line

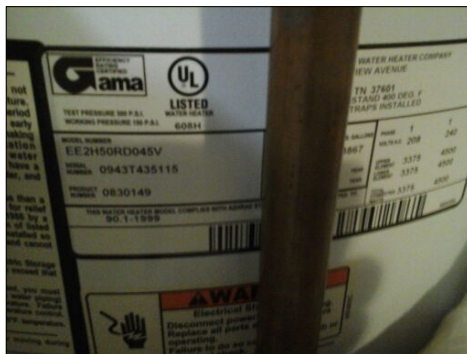
There was a Whirlpool 50 gallon electric water heater installed in the garage, and it was approximately 5 Years old.

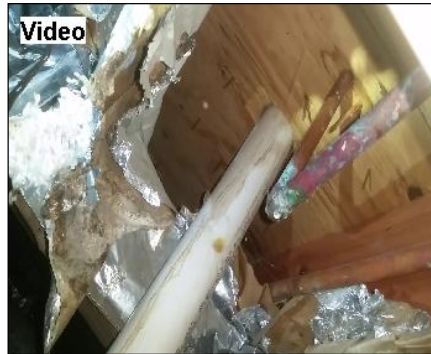
5.1. There were leaking distribution pipes in that should be repaired by a qualified plumbing contractor to avoid damage to home materials or the development of conditions which encourage the growth of microbes such as mold. LOCATION: under kitchen sink

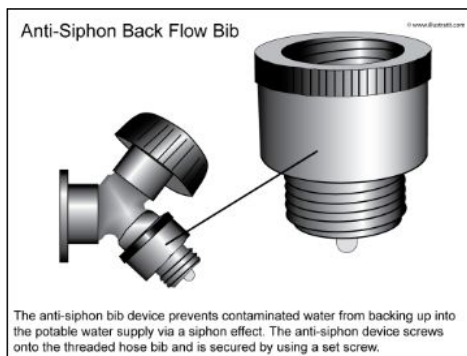
If anti-siphon devices are not present at all the exterior faucets there is a potential for cross contamination. The inspector recommends installing anti-siphon devices at hose bibs that do not currently have this protection.

Anti-Siphon device example

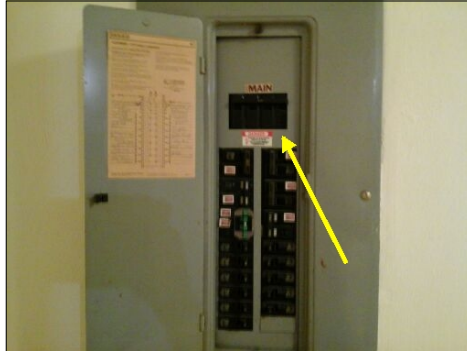
The main conductor lines are underground, or part of a lateral service entrance. This is characteristic of modern electrical services but, inasmuch as the service lines are underground and cannot be seen, they are not evaluated as part of our service. The electrical meter is located at the rear of the house.

Main shutoff location: laundry room

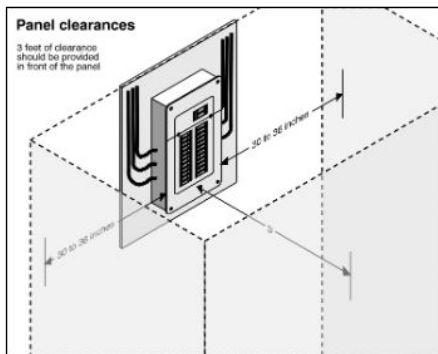
2.1. FYI: The main electrical service panel did not have proper clearances to provide quick access for an emergency disconnect. This condition should be corrected. The clear working space required in front of a panel is 30" wide by 36" deep with a minimum headroom clearance of 6' 6".

Panel clearance information

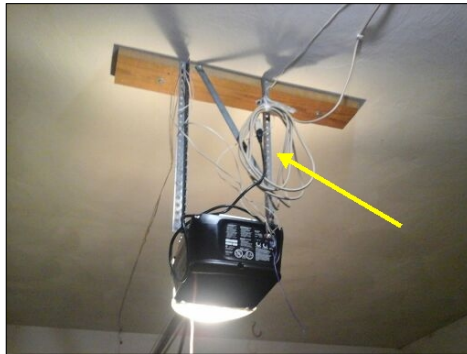
6.1. There was extension cords being uses for permanent wiring. You should have this removed or a permanent method of wiring installed. LOCATION: Garage at garage door opener

Extension cord wiring

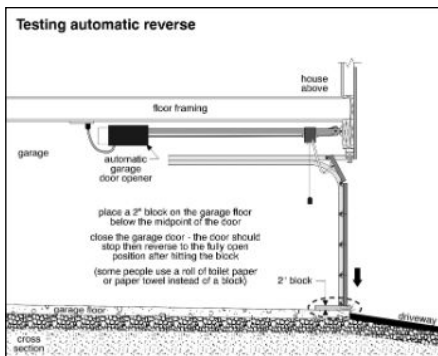
3.3. **SAFETY CONCERN:** The garage door safety reverse by force did not operate when tested. It may need to be adjusted or repaired.

Testing automatic reverse information

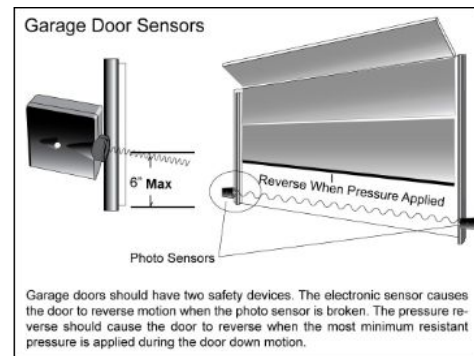
3.2. **SAFETY CONCERN:** The garage door opener safety eye sensors were higher than the 6" recommended by DAMSA(Door & Access Systems Manufacturers Association). You should have them lowered.

Garage door safety sensor information

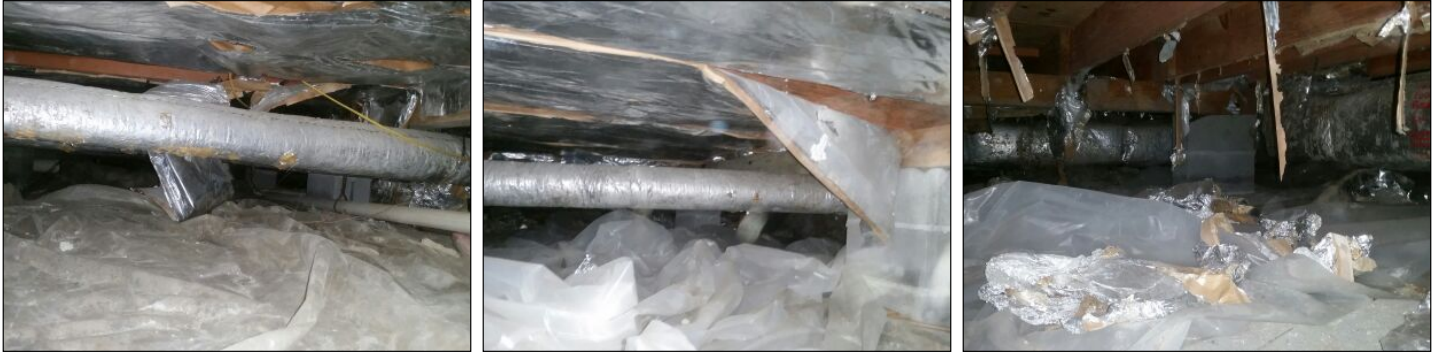
The house had a **crawlspace foundation**. The pictures demonstrate that the inspector crawled accessible areas where it could be done safely. There are some typical restrictions to the inspection including but not limited to the electrical wires, pipes, storage, ductwork, insulation, access, debris etc...We are unable to report defects concealed by these items. The crawlspace access was located at: REAR OF THE HOUSE

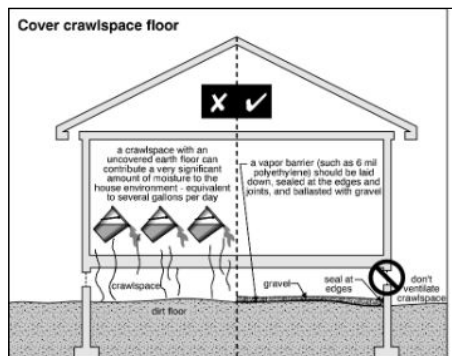
2.4. There was evidence of bio growth and WDO presence in multiple areas of the crawlspace. The majority of the crawlspace framing was not visible due to the installation of a radiant barrier. The radiant barrier was rendered ineffective by damage in multiple areas. It is recommended that the barrier be removed to allow for a full inspection for possible moisture damage and WDO damage.

Crawlspace cover example

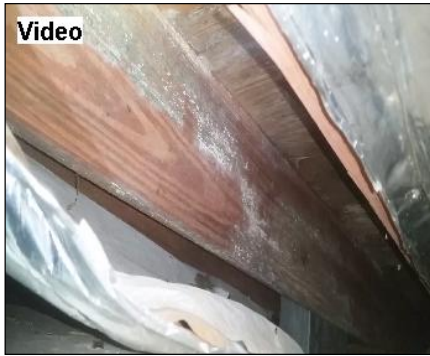
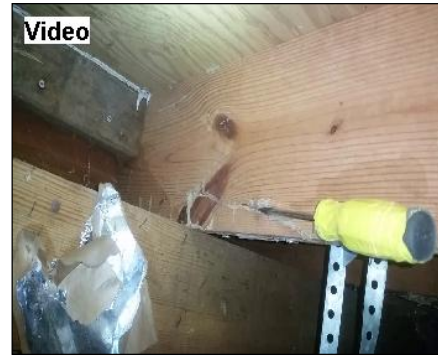
2.1. There were indications of possible microbial, fungal, or mold like growth. This condition typically indicates a moisture problem. The source of moisture should be identified and the condition corrected to avoid possible damage to the structure and poor indoor air quality. You should have a professional termite and moisture company perform a complete inspection of the home and make recommendations to correct any damage that may be present.

2.3. There were indications of a wood destroying organism (WDO) presence, evidenced by damaged wood in the crawlspace. The inspector recommends inspection by a qualified pest control contractor.
